MJC TREE SERVICES LIMITED

Site:  
XXXXXXXXXX.

TREE CONSTRAINTS PLAN

Plan no. MJC-15-0122-01  
rev:0

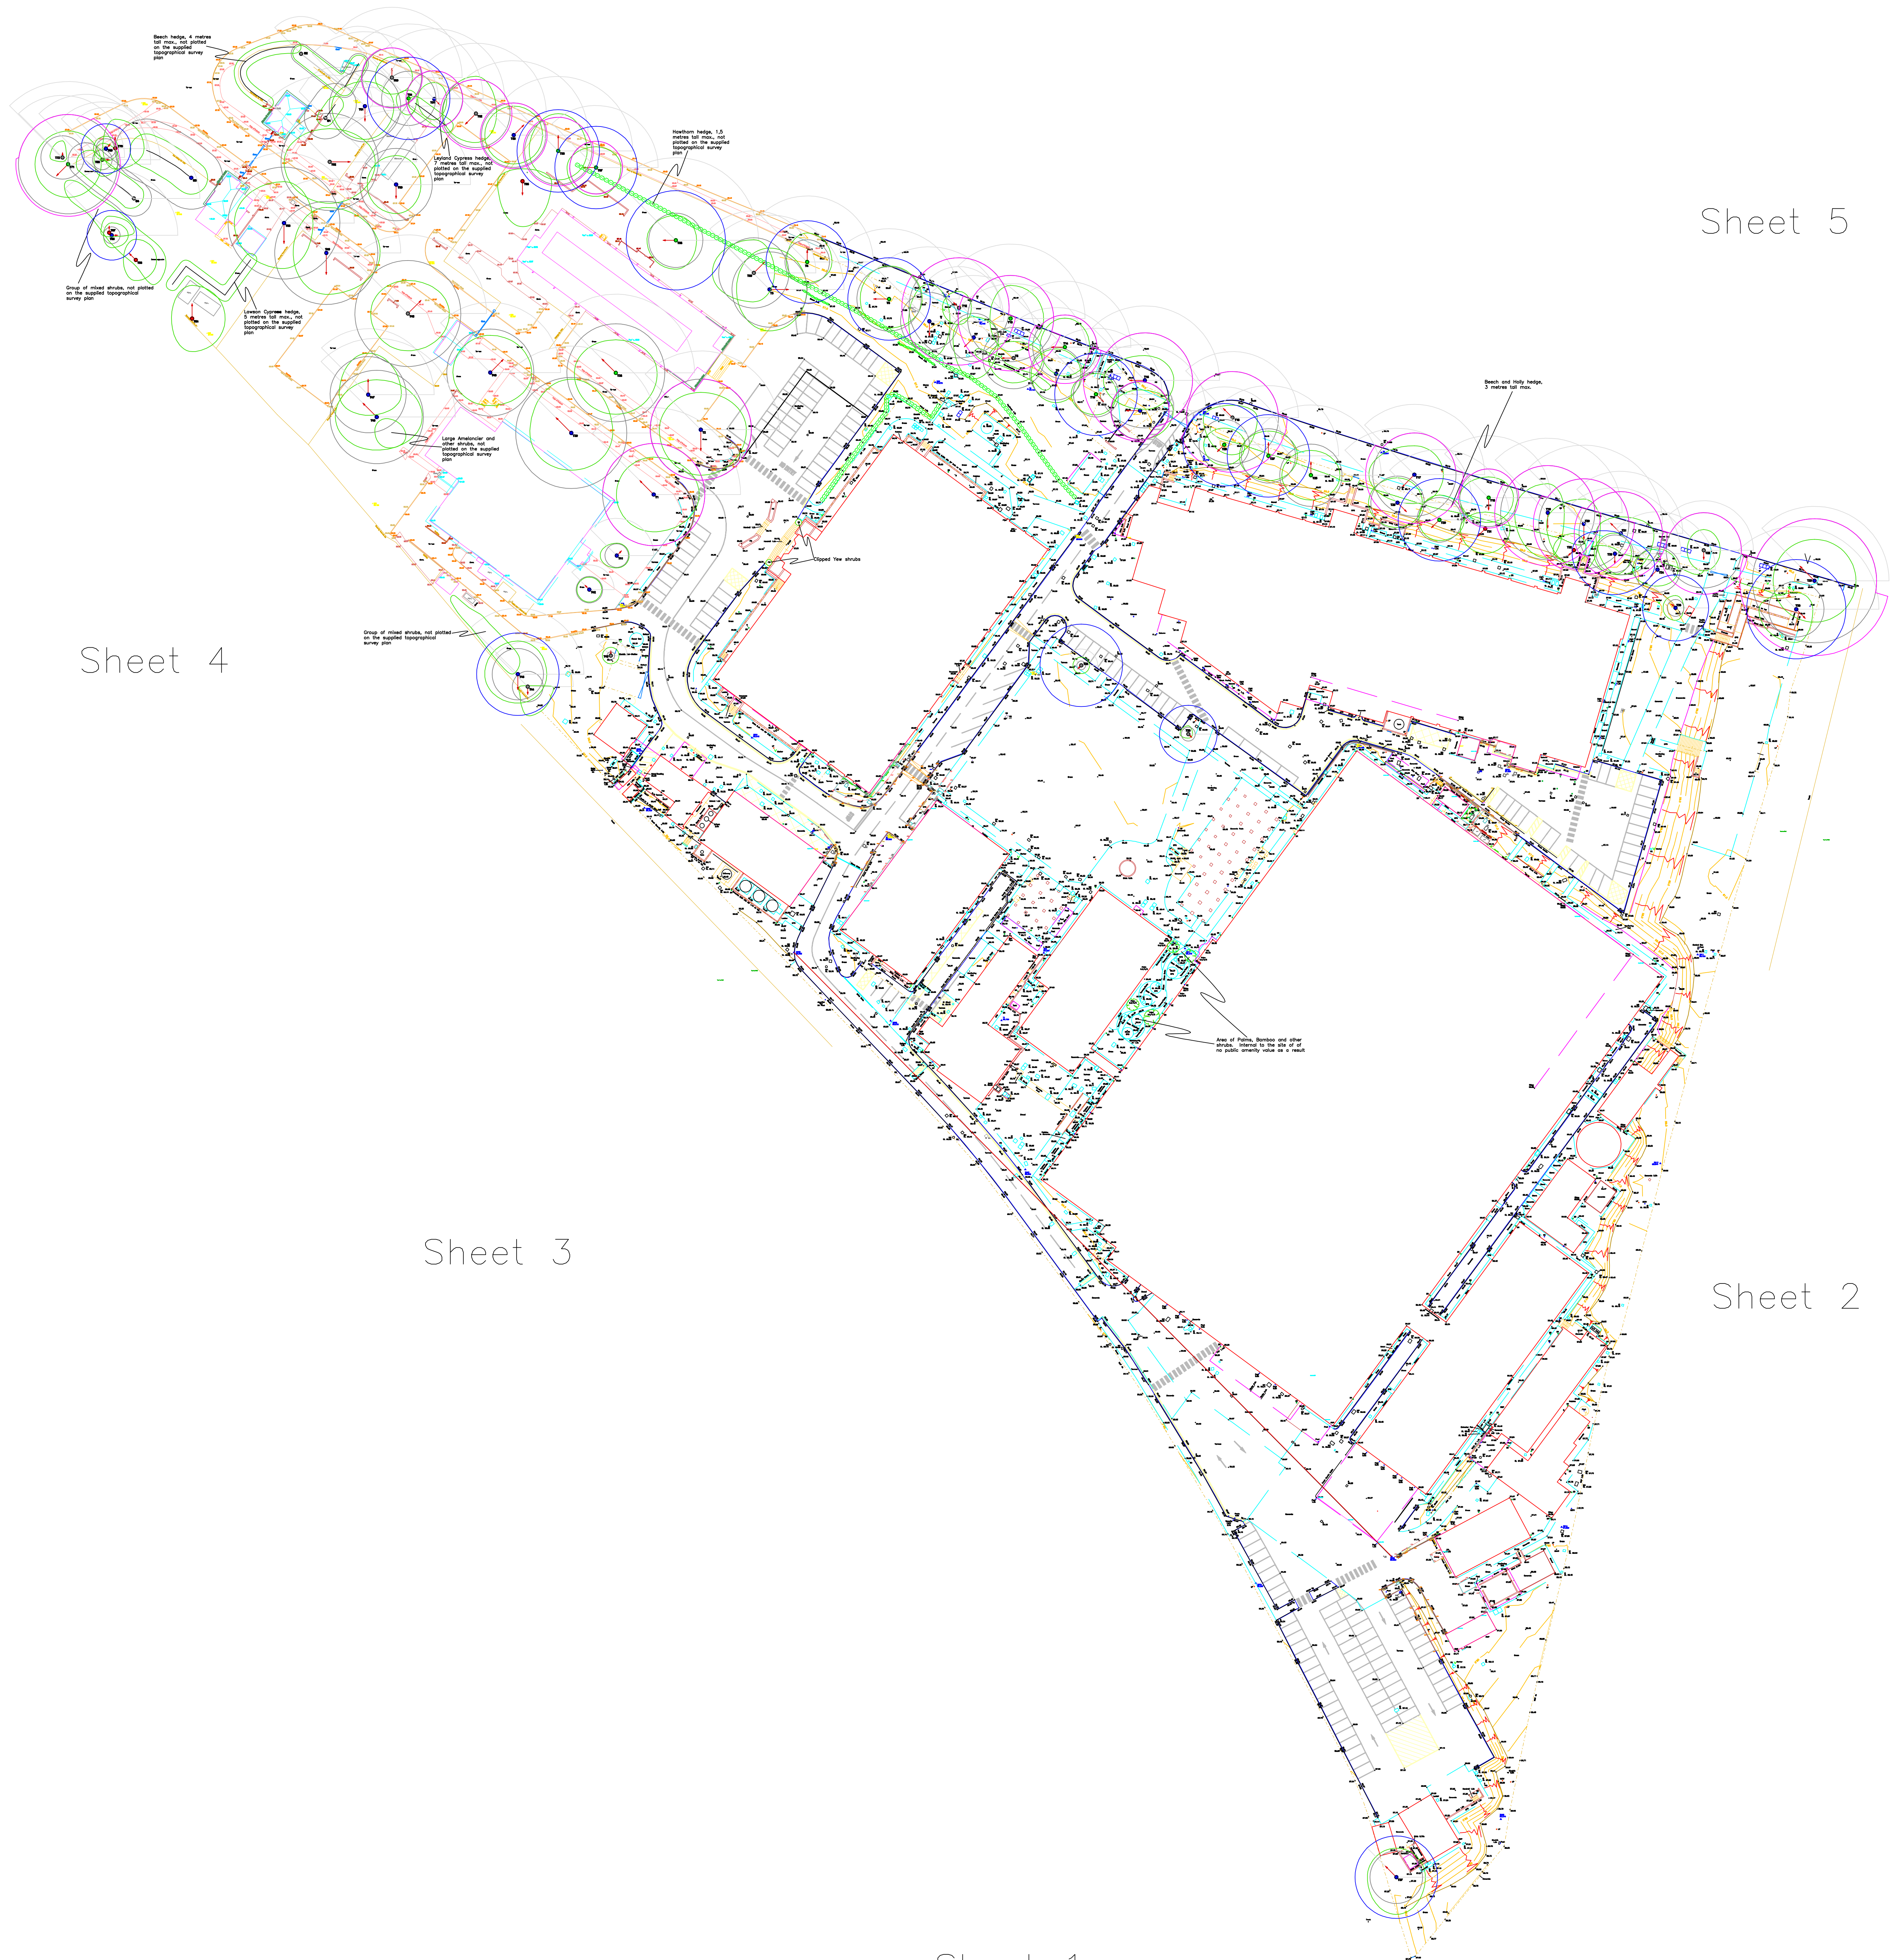
- The site contained a great number of trees, many of which had clearly been planted as part of a long standing and formal landscaping exercise.
- The tree constraints have been calculated and are illustrated in accordance with BS5837:2012.

- A number of trees and groups included in the survey were omitted from the supplied site plan, namely tree no's. T41, T42, T44, T45, T50, T54, T57, T58, T64, T65, T66, T67, T68, T69, T70, T71 and T72, and group no's. G2, and part of G4. The positions of these trees and groups were estimated by eye while the author was on site. This issue is also noted on the tree survey schedule. If the position of any of these trees is critical to any proposed development of the site, their position should be confirmed by a competent land surveyor and this plan adjusted accordingly.

- Root Protection Areas (RPA)
  - The indicative RPA of several trees extend under the footprint of existing and substantial buildings, other light structures, the carriageway and footpath of the highway, the rail line verges and onsite hard surfaces. In order to compensate for these factors, a modified RPA has been plotted for these trees, illustrated as a magenta irregular polygon in this plan, and this is based on the following reasoning.

- Where the indicative RPA extends under the footprint of substantial buildings it has been considered reasonable to assume that the foundations of these buildings will have acted as an effective barrier to root growth. To compensate for this, areas of RPA that extend under the footprint of existing and substantial buildings have been excluded, and an equivalent area has been evenly added to the remaining RPA that was considered unrestricted to create a modified RPA.

- Where the indicative RPA extends under the carriageway of the highway it has been considered reasonable to assume that the construction of the carriageway, and the installation and maintenance of underground services within the carriageway, would have restricted, but not prevented, root growth under the carriageway. To compensate for this, 50% of the areas of RPA that extend under the carriageway have been evenly added to the remaining RPA that was considered unrestricted to create a modified RPA.

- Where the RPA extends under existing onsite hard surfaces, light buildings and structures, the pavement and verge of the highway, and the rail line verge, it has been considered reasonable to assume that these have not formed a significant barrier to root growth and no modification has been considered necessary.
